Manhole Inspection Summary

Manhole # S13EE2006MH

Insp Date: **9/28/06 1:17 PM**

Location Address: **5800 CREST RD**

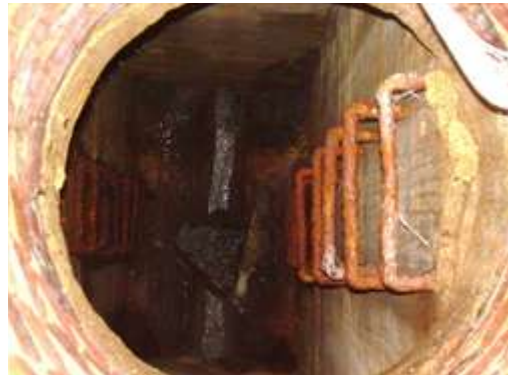
Top View

Corroded steps. Bench debris.

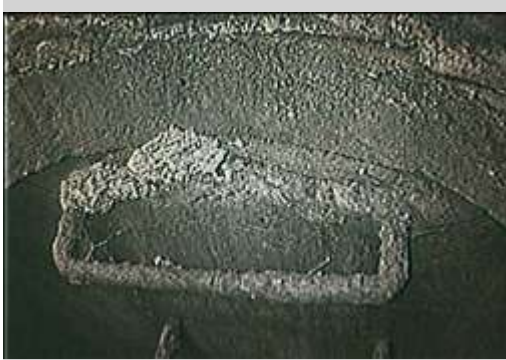
Defect

Infiltration: ☐ None ☒ **Joint** ☐ Cracks ☒ **Mortar** ☐ Roots ☐ Wall

Chimney infiltration.

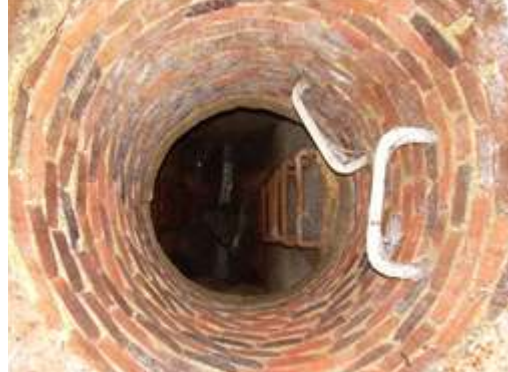
Defect

Infiltration: ☐ None ☒ **Joint** ☐ Cracks ☐ Mortar ☐ Roots ☐ Wall

Adjustment and Corbel infiltration.

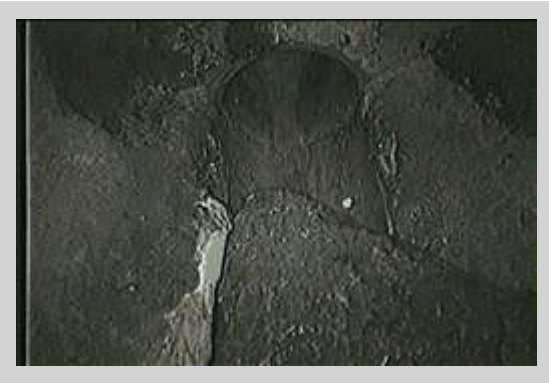
8 in. Circular Gravity Sewer Pipe Out @ 12 O'Clock

Infiltration: **Evidence** Pipe Seal Cond: **Cracked**

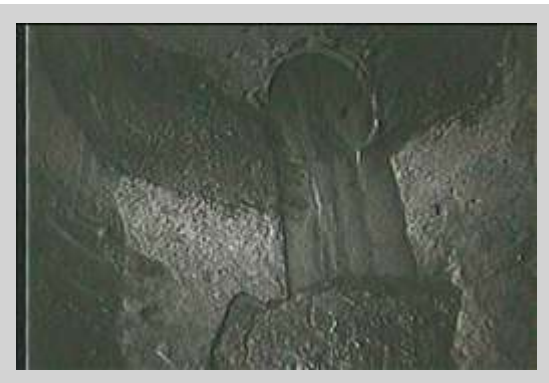
8 in. Circular Gravity Sewer Pipe In @ 6 O'Clock

Infiltration: **Evidence** Pipe Seal Cond: **Cracked**
